OV-1

ACCIDENT SUMMARY

MAJORS • MINORS • INCIDENTS • FORCED LANDINGS

NOVEMBER 1, 1961 TO OCTOBER 31, 1963

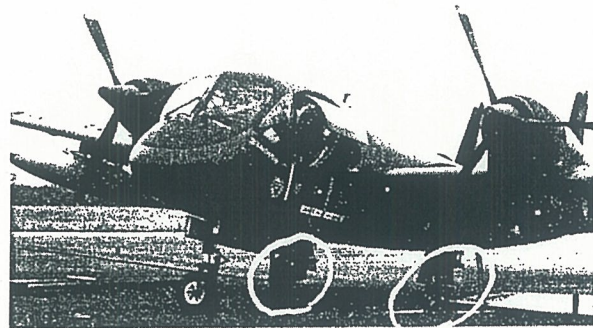
03844

THE ACCIDENT: Landing gear inadvertently retracted on landing.

THE CAUSE: IP accidentally moved gear handle instead of flaps lever during roll of touch and go landing.

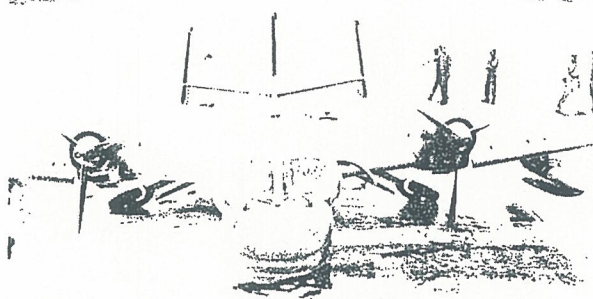
04106

THE ACCIDENT: Pilot made high, fast downwind approach. In an effort to reduce speed, he retarded the power control levers abruptly, causing them to go beyond the ground idle stop into the reverse thrust position. The aircraft dropped to runway and slid to a halt.

THE CAUSE: High, fast downwind approach and use of reverse thrust before touchdown.

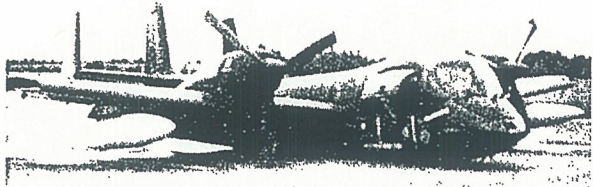
04200

THE ACCIDENT: Nose gear collapsed during landing roll on sod strip. Pilot applied full reverse thrust at touchdown and nose gear drag brace failed, allowing wheel to retract.

THE CAUSE: Materiel failure.

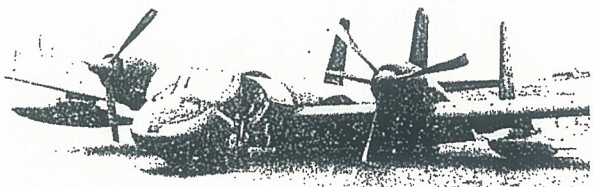
04400

THE ACCIDENT: Nr. 1 engine propeller feathered during single engine go-around demonstration and airspeed dropped below single engine speed. Power was applied to Nr. 2 engine and flaps were raised. Aircraft went into shallow left turn, stalled, and crashed in nose-low attitude. Pilot and instructor pilot killed.

THE CAUSE: IP allowed airspeed to drop excessively and then raised the flaps. This caused loss of inboard ailerons which further reduced controllability of aircraft. External loads were not jettisoned. Cause of propeller feathering undetermined.

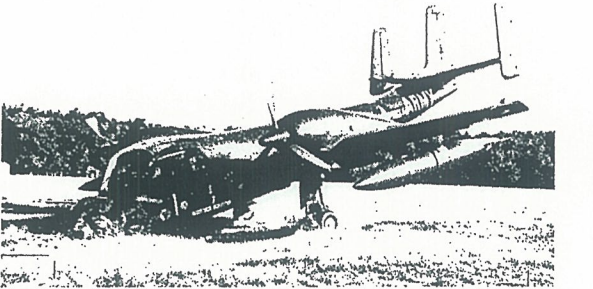
04876

THE ACCIDENT: Aircraft dropped in from approximately 50 feet, landed hard, bounced, and skidded to stop.

THE CAUSE: Power control levers were inadvertently moved to reverse thrust during approach.

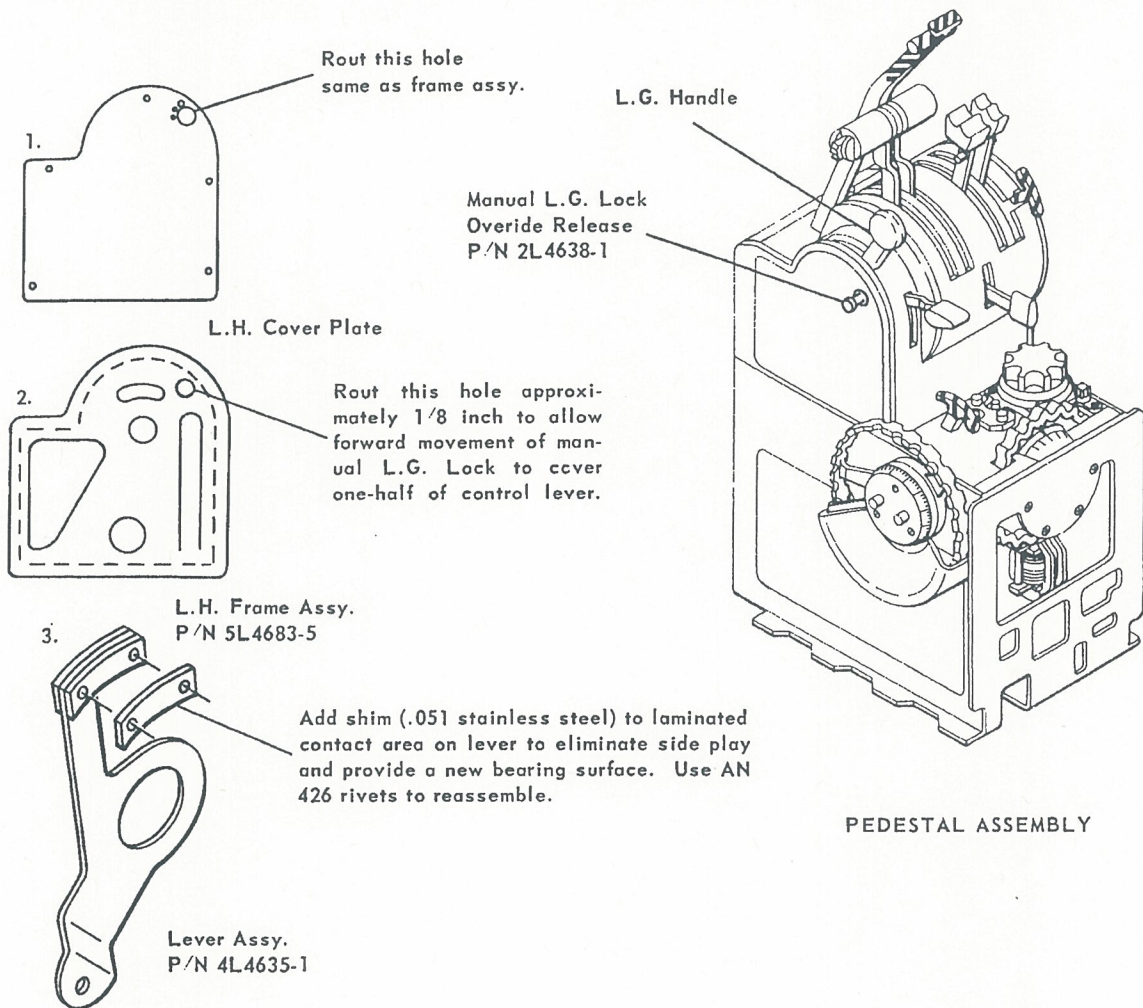
Due to several inadvertent landing gear retractions, MWO 55-1510-204-34 '1, 21 Nov 1961, was issued covering inspection of the landing gear lever. Inadvertent retractions can be caused by wear in various parts of the pedestal assembly. Repair as shown should be incorporated during the next scheduled periodic inspection.

TO PREVENT INADVERTENT RETRACTION OF LANDING GEAR DUE TO WEAR AND TOLERANCE BUILD UP OF POSITION LOCK, REWORK THE THREE PARTS SHOWN BELOW.
