## *crash sense*

# OV-1 EJECTION

*OV-1 loss caused by  
water in fuel*

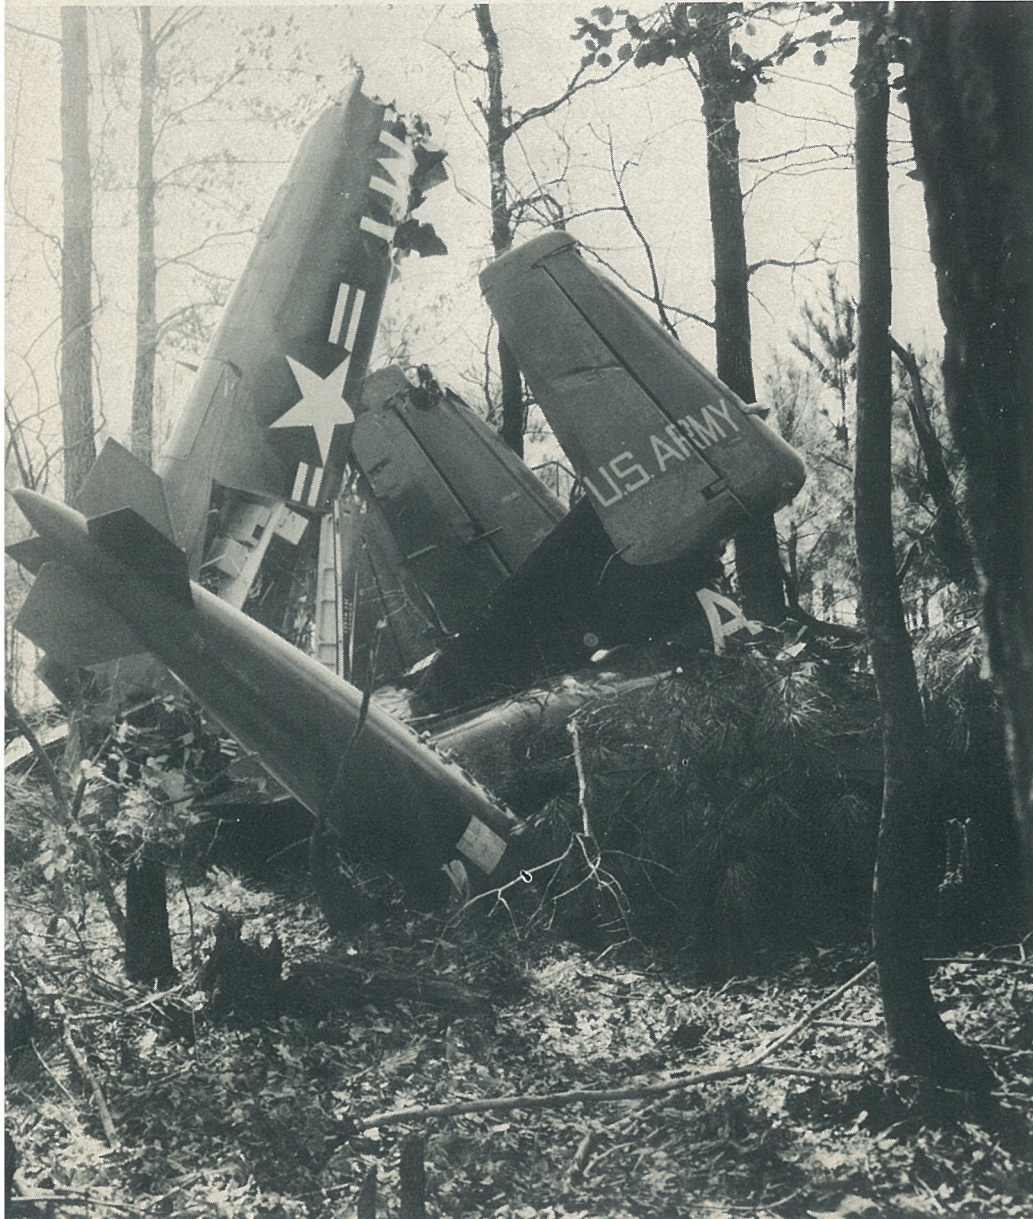
Both engines were sent to a laboratory for tear-down analysis to determine the cause of simultaneous failure. Here are the conclusions of this analysis: "Engine failure and loss of electrical power were caused by flameouts induced by the excessive amounts of contamination (water) noted in the fuel samples that were drawn from the fuel controls during engine disassembly. The chlorine traces found in the samples indicate that the water had been treated for drinking purposes."

The laboratory recommended that petroleum servicing personnel should be shown the Air Force training film, TF 1-5345, "Fuel Contamination—Jet Age Killer." This film covers the steps to be taken and procedures to be followed at base level in the control and handling of aircraft fuel.
