OV-10

ACCIDENT SUMMARY

OY-1 ACCIDENT SUMMARY

1 July 1963 through 30 June 1966

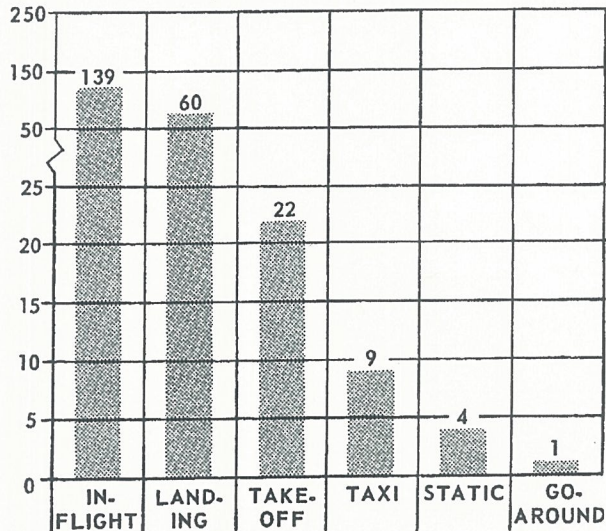
FIGURE 1
Phase of Operation in Which Mishap Started

VIII. PHASE OF OPERATION: Figure 1 shows the phases of operations in which mishaps started. The inflight phase accounted for 59% of all mishaps and the landing phase accounted for 25%. The majority of mishaps were caused by materiel failures or malfunctions.

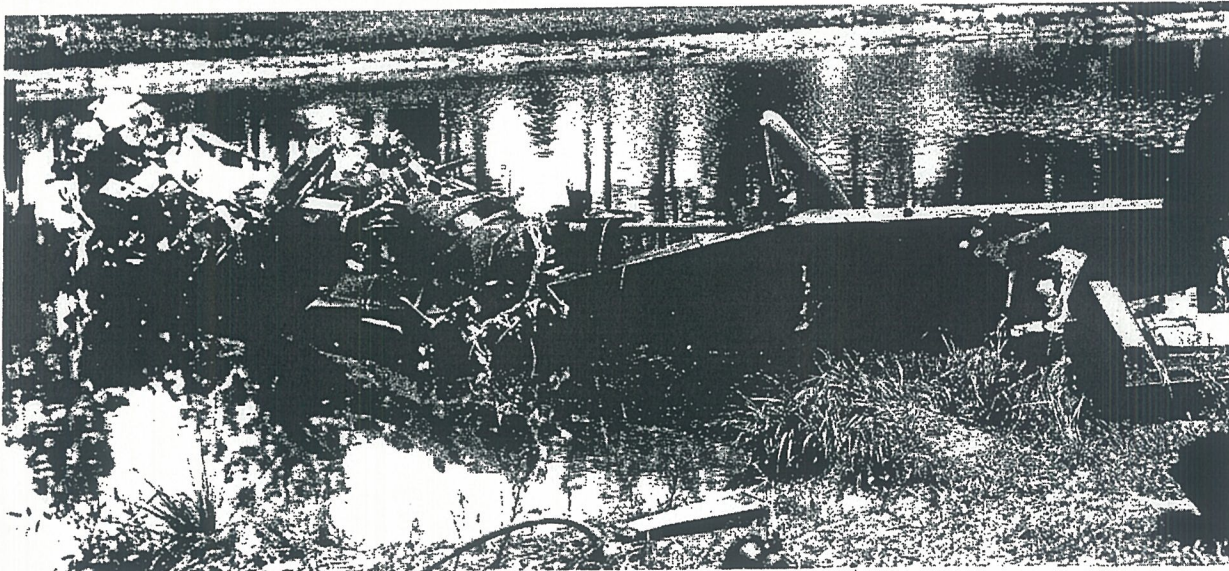
E421

E421—On completion of a short field landing, takeoff was attempted with approximately 3,600 feet of runway remaining. At an undetermined point in the

takeoff sequence, No. 1 engine failed. Aircraft struck the tops of trees, left wing low, and crashed in an inverted position approximately 1,500 feet from end of runway. The instructor pilot received fatal injuries and the pilot received major injuries. The primary cause of this accident was failure of the left engine due to intergranular stress corrosion of the disc in the 5th stage compressor. Contributing factors were: 1. No. 1 propeller was not feathered. 2. The flight crew, for reasons unknown, most probably did not arm the auto-feather circuit. 3. Engine failure occurred at a relatively low airspeed. Coupled with the propeller not being feathered, this set up an uncontrollable flight condition.

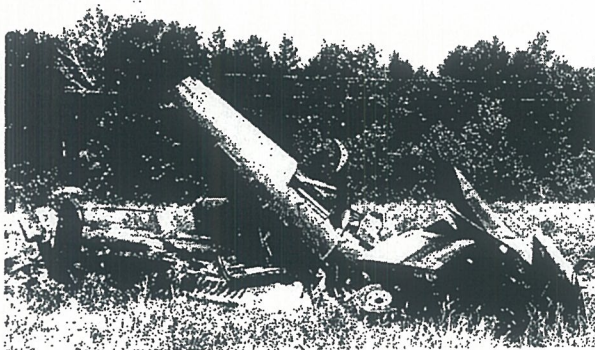
08113

08113—Aircraft struck two 3/8" ground cables located above high tension electrical power lines. The wires broke and aircraft hit a 40-foot pine tree, coming to rest in the center of a pond, and scattering debris throughout the pond and 55 yards up the side of a hill. Caused by: 1. Aircraft flying into 3/8" steel ground cables. 2. Difficulty in detecting wires from low altitude. 3. Failure to indicate location of a known flight hazard on maps used during low level flight. 4. Lack of positive instructions on gunnery procedures to be used during combined arms training exercises. 5. Conducting instruction in low level gunnery techniques to a non-gunnery qualified pilot during a combined arms training exercise.

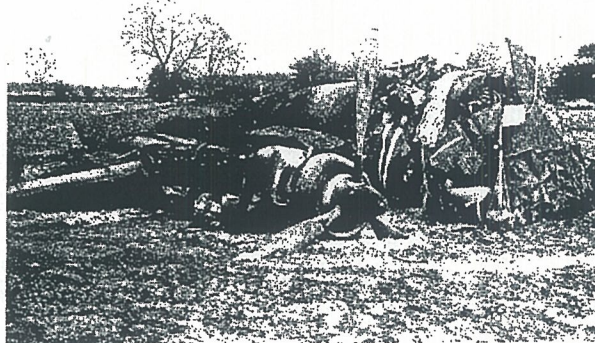
C664

C664—Aircraft departed airfield and was climbing through 4,200 feet when the No. 1 engine caught fire. Fire could not be extinguished with internal fire bottles. Both the instructor pilot and pilot made a safe ejection at 1,600 feet and received only minor injuries. The primary cause of this accident was a fire in the area of the No. 1 engine caused by misalignment of the dowel pin located in the No. 4 bearing pump housing and retainer ring, causing pressurization of the No. 3 and 4 bearing package. Pressurization resulted from inability of the front pump located forward of No. 3 bearing to evacuate the additional oil. The oil was then forced between the carbon seal and the power turbine stub shaft seal journal. This resulted in the erosion of the carbon seal, loss of lubrication, and subsequent failure of the No. 3 and 4 bearings.

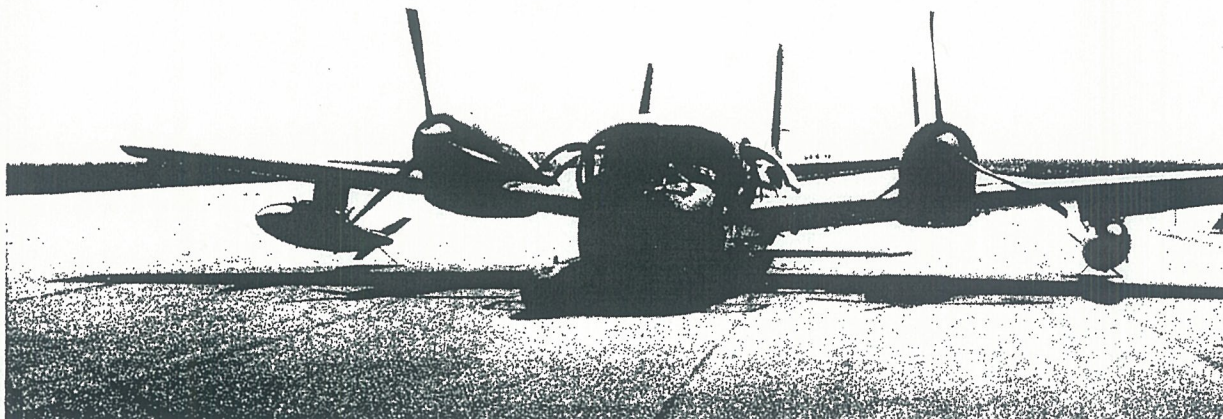
C122

C122—Aircraft was landed gear-up. Caused by failure to lower landing gear. Pilot did not use pre-landing checklist.

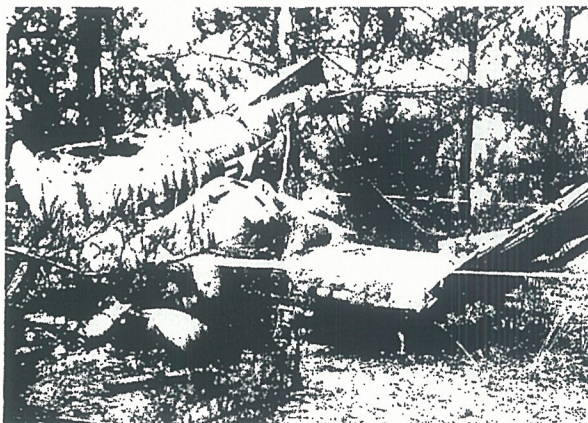
E103

E103—Aircraft was on an authorized night VFR training flight. Clearance had been obtained for a touch-and-go landing from an ILS approach. Landing was completed at approximately mid-field and power applied for takeoff. Aircraft became airborne about three-quarters of the distance down the runway. Aircraft veered to the right 45° from the takeoff heading, traveled a distance of 1,500 feet, crashed and burst into flames. Both occupants received fatal injuries. Probable cause of the accident was inadvertent feathering of the No. 2 engine propeller on takeoff. Contributing factors were: 1. Inability of the flight crew to cope with an emergency that was self-induced. 2. Lack of standardization of instructor pilot. 3. Touch-and-go landings at night.
