ARMY CONCEPT TEAM IN VIETNAM
APO San Francisco 96243

**EMPLOYMENT OF US ARMY
AVIATION COMPANY (AERIAL
SURVEILLANCE) IN COUNTER-
INSURGENCY OPERATIONS (U)**

REPORT EVALUATION BY DIRECTOR, JRATA

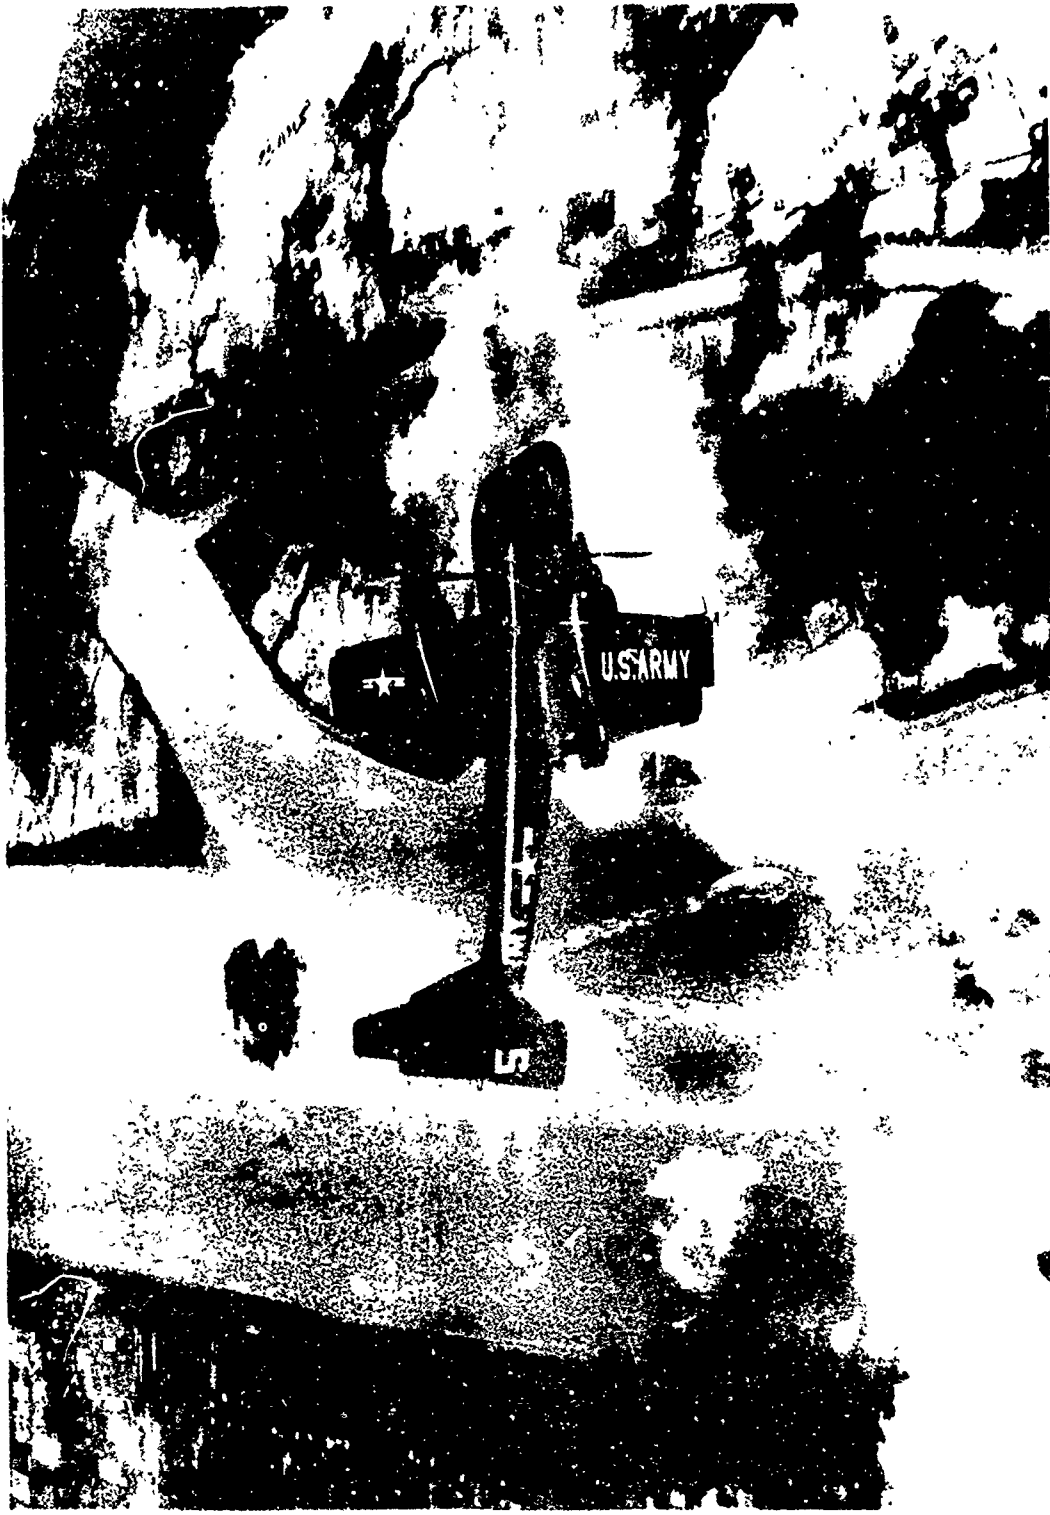
(U) FIGURE 1. OV-1 (Mohawk) over the Mekong Delta.

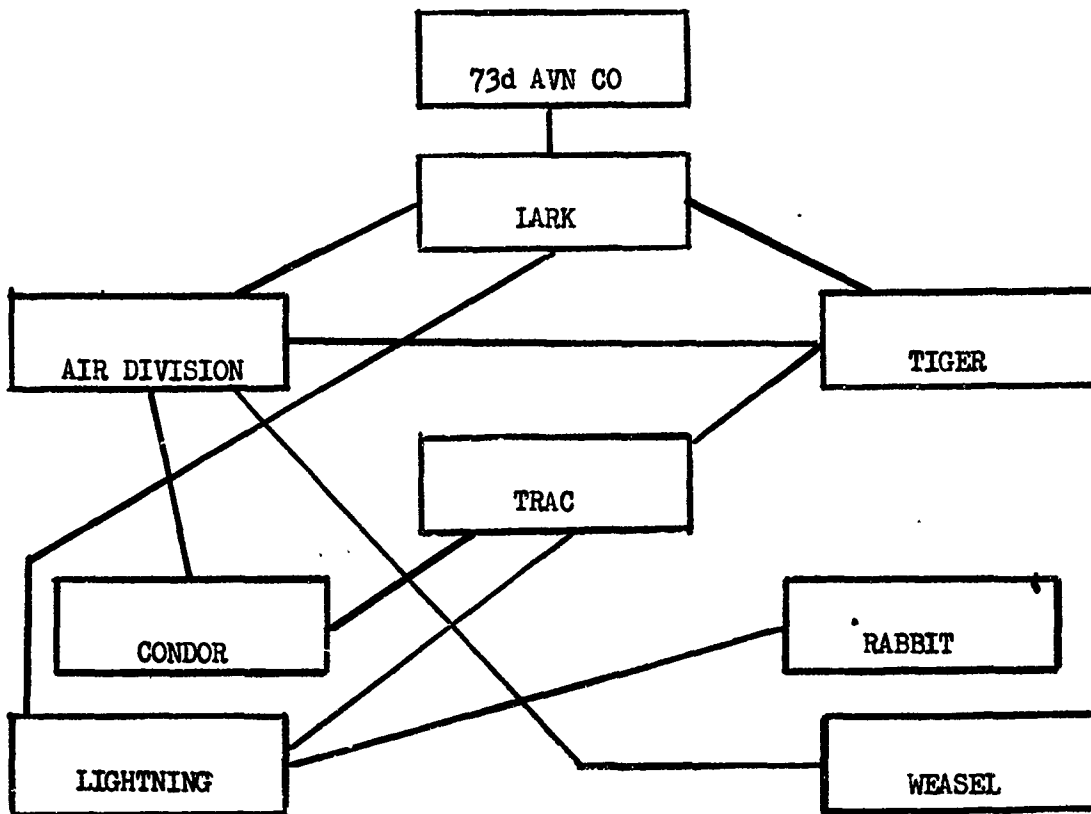
(U) FIGURE 5. Telephone traffic diagram.

The two AN/GRC-46 radio teletype sets provided for communications between the company and the supported units were inadequate during the evaluation. Distances between the 73d Avn Co and flight teams at Qui Nhon was 260 miles, well beyond the range of these radios. As a result, the telephone was used for communication even though much difficulty was experienced. A telephone traffic diagram is shown in figure 5.

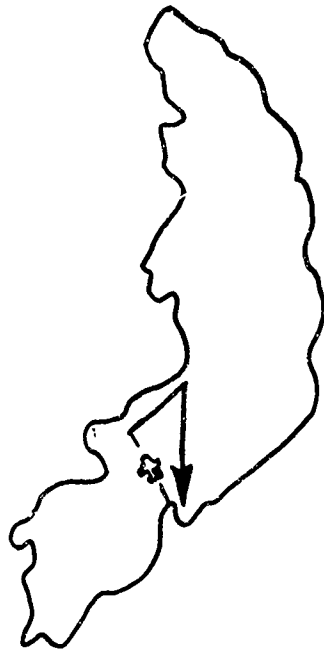
(U) FIGURE B-7. SLAR area search, technique 1.

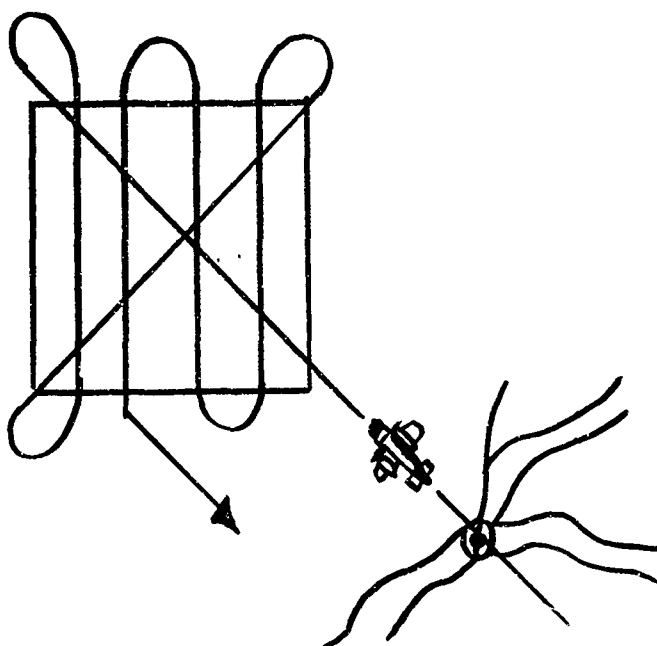
(U) FIGURE B-9. IR area search, technique 1.

Figure B-9 illustrates a small area search pattern using IR surveillance. This pattern was flown at about 1500 feet absolute altitude and an attempt was made to eliminate multiple parallel passes as much as possible to preclude enemy anticipation of future positions. In this sketch the tip of the island in the river is used as an identifiable checkpoint that would be seen in the terrain display scopes as the aircraft passes overhead. Knowing the doppler coordinates of this checkpoint allowed the aviator to up-date his computer, thus eliminating any errors. This mission was flown with the aircraft blacked out and the aviator relying solely on his doppler navigator for navigation.
