OV-1

ACCIDENT SUMMARY

MAJORS • MINORS • INCIDENTS • FORCED LANDINGS

NOVEMBER 1, 1961 TO OCTOBER 31, 1963

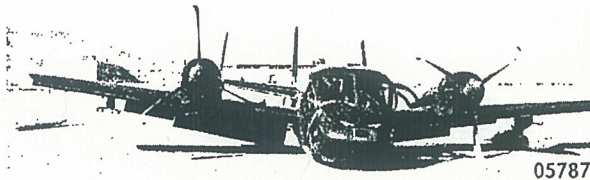
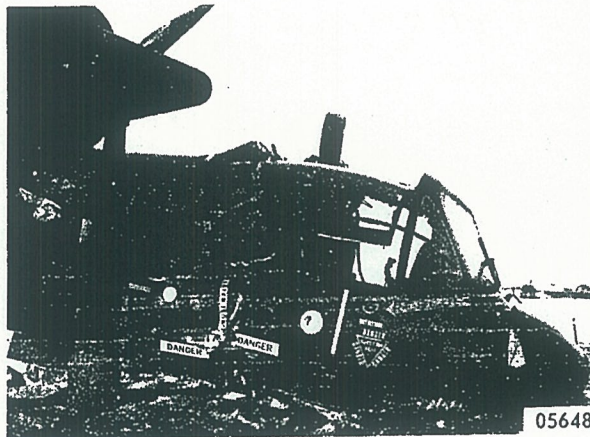
04200

fuselage in vicinity of flare pod when remaining flares were salvoed in completion of night photo mission. Fuselage broke in two and aircraft crashed. Pilot ejected and sustained minor injuries. Copilot failed to eject and sustained fatal injuries.

THE CAUSE: The most probable cause of this accident was premature firing of one or more flares which caused an explosion in the flare pod.

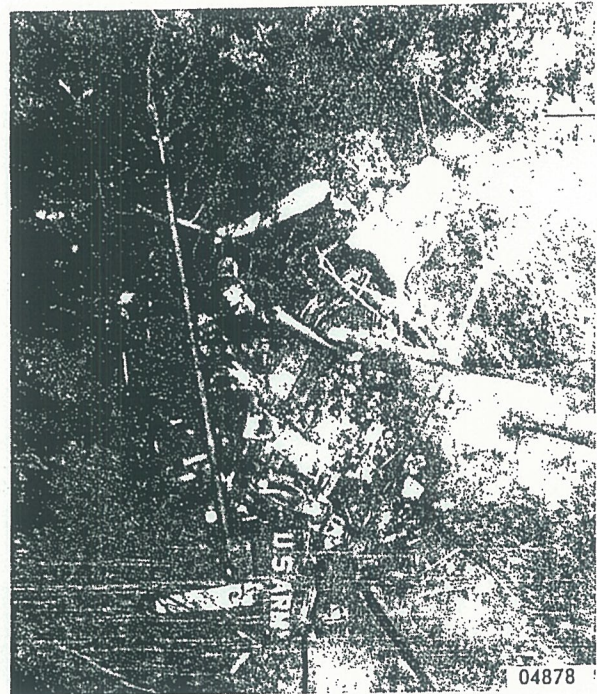
THE ACCIDENT: Aircraft struck power lines during low level visual surveillance mission. Major damage to empennage, fuselage, wings, and propellers.

THE CAUSE: Failure to see and avoid wires. Low

visibility at early dawn in light rain considered possible contributing factor.

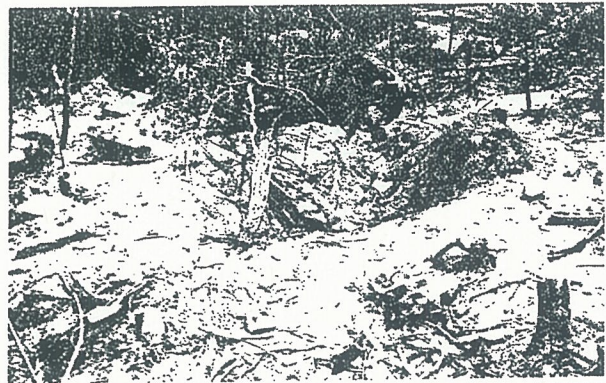
06734

causing blowout of nose wheel tire as propellers were reversed during strip landing. Nose gear collapsed. Major damage to wing, center section, fuselage, landing gear, flaps, propellers, and engine.

THE CAUSE: Presence of loose rocks on runway.
