OV-10

ACCIDENT SUMMARY

OY-1 ACCIDENT SUMMARY

1 July 1963 through 30 June 1966

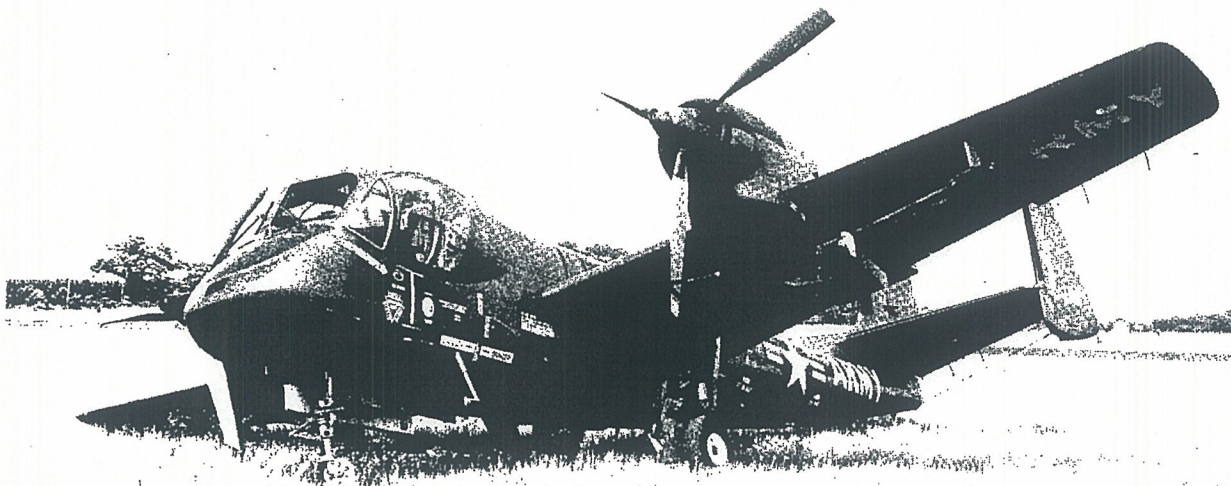
E421—On completion of a short field landing, takeoff was attempted with approximately 3,600 feet of runway remaining. At an undetermined point in the

takeoff sequence, No. 1 engine failed. Aircraft struck the tops of trees, left wing low, and crashed in an inverted position approximately 1,500 feet from end of runway. The instructor pilot received fatal injuries and the pilot received major injuries. The primary cause of this accident was failure of the left engine due to intergranular stress corrosion of the disc in the 5th stage compressor. Contributing factors were: 1. No. 1 propeller was not feathered. 2. The flight crew, for reasons unknown, most probably did not arm the auto-feather circuit. 3. Engine failure occurred at a relatively low airspeed. Coupled with the propeller not being feathered, this set up an uncontrollable flight condition.
